Re: Village of Cuba Wastewater Treatment Plant; Minor Municipal; Individual Permit; SIC 4952; NPDES Compliance Evaluation Inspection; NM0024848; April 20, 2016

NPDES Compliance Inspection Report

**Village of Cuba WWTP
Compliance Evaluation Inspection
NPDES Permit No. NM0024848
April 20, 2016
Further Explanations**

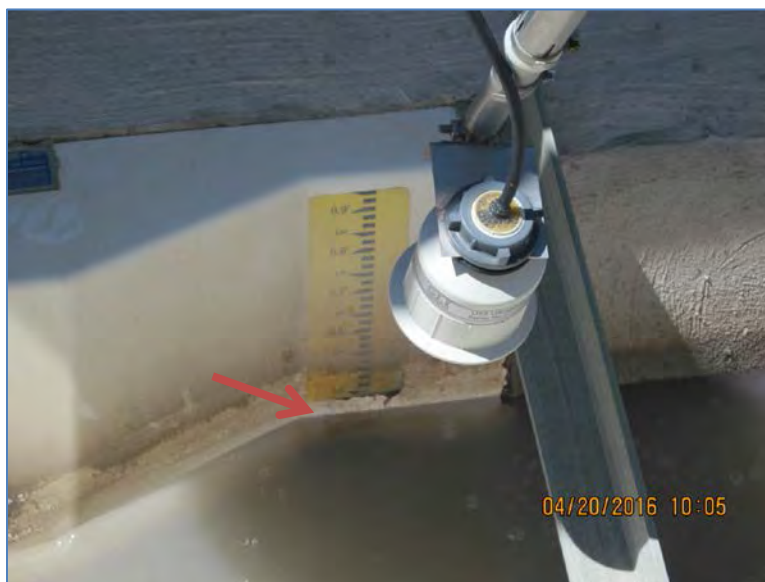
NMED/SWQB Official Photograph Log Photo # 1		
Photographer: Erin S. Trujillo	Date: 04/20/2016	Time: 1105 hours (corrected)
City/County: Village of Cuba / Sandoval County		State: New Mexico
Location: Village of Cuba WWTP, MM 2 SH 197, Cuba, NM		
Subject: Arrow points to missing portion of influent flume gage.

- Influent flume gage was missing the lower measurements marks (see Photo Log).
- A crate was installed after the headworks in the basin labeled grit tank on plans submitted with the Permittee's 2015 application (see Photo Log). The crate collects both solids and grit according to the on-site operator supervisor. Collected solids in the crate appear to need more frequent removal and proper disposal. Larger solids can damage or adversely affect plant equipment performance.

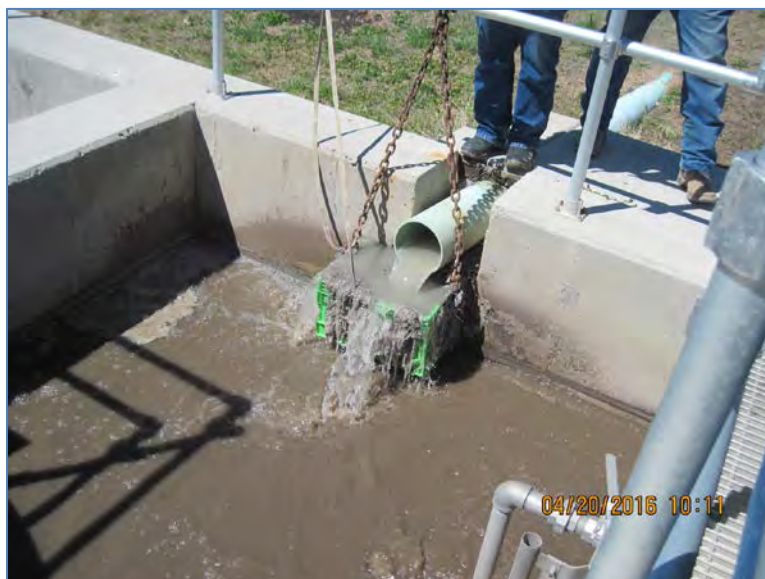
NMED/SWQB Official Photograph Log Photo # 2		
Photographer: Erin S. Trujillo	Date: 04/20/2016	Time: 1111 hours (corrected)
City/County: Village of Cuba / Sandoval County		State: New Mexico
Location: Village of Cuba WWTP, MM 2 SH 197, Cuba, NM		
Subject: Crate installed after the headworks in the basin labeled grit tank on plans submitted with the Permittee's 2015 application.

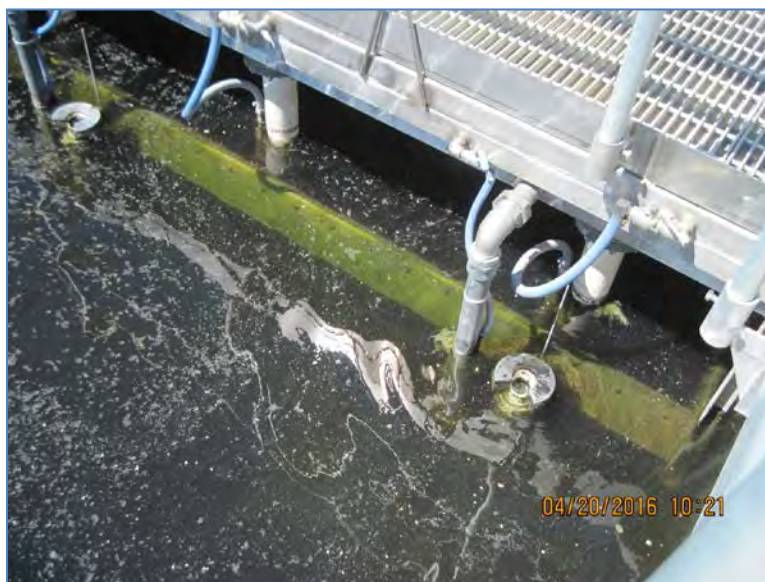
NMED/SWQB Official Photograph Log Photo # 3		
Photographer: Erin S. Trujillo	Date: 04/20/2016	Time: 1121 hours (corrected)
City/County: Village of Cuba / Sandoval County		State: New Mexico
Location: Village of Cuba WWTP, MM 2 SH 197, Cuba, NM		
Subject: Floating solids were observed in one of the two secondary clarifier basins (southern basin)

- Floating solids were observed in the secondary clarifier (See Photo Log).
- Slight algal growth was observed on the sides of the open channel at the UV system (See Photo Log). Algal growth that dislodges into the effluent can adversely affect effluent quality--increase TSS monitoring results.

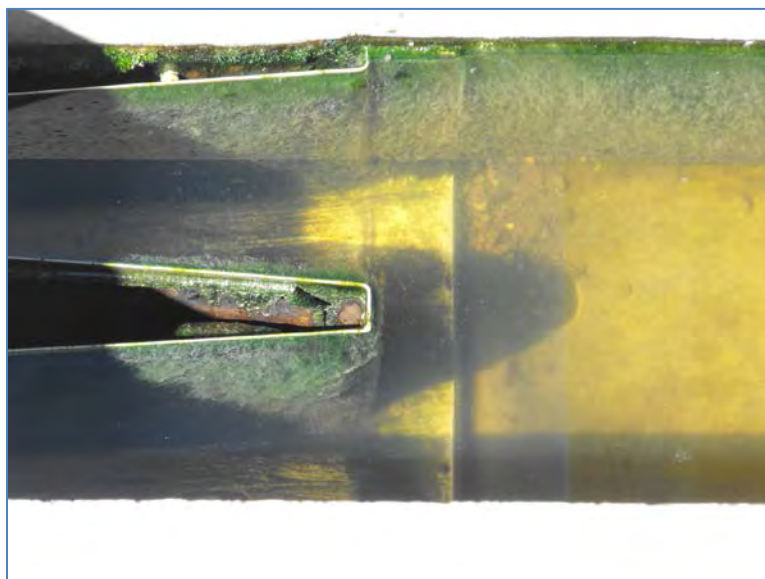
NMED/SWQB Official Photograph Log Photo # 4		
Photographer: Daniel Valenta	Date: 04/20/2016	Time: 1124 hours
City/County: Village of Cuba / Sandoval County		State: New Mexico
Location: Village of Cuba WWTP, MM 2 SH 197, Cuba, NM		
Subject: Algal growth was observed on the sides of the open channel following the UV system.

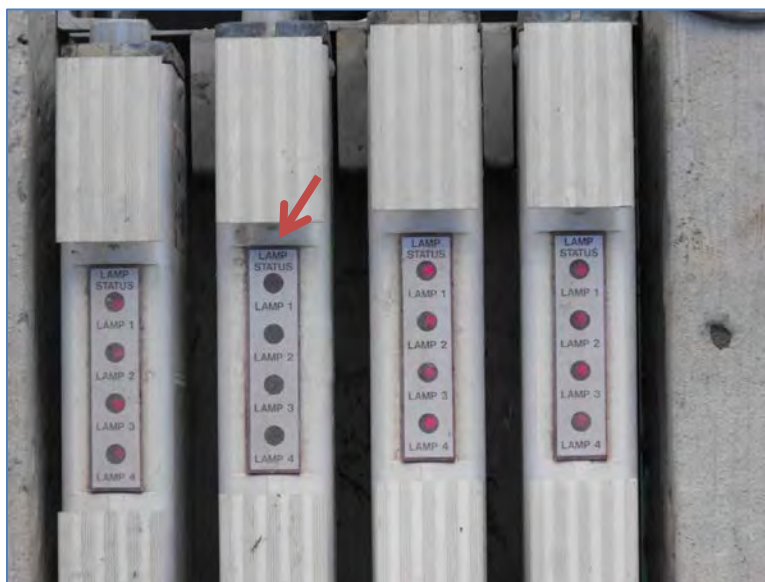
NMED/SWQB Official Photograph Log Photo # 5		
Photographer: Daniel Valenta	Date: 04/20/2016	Time: 1125 hours
City/County: Village of Cuba / Sandoval County		State: New Mexico
Location: Village of Cuba WWTP, MM 2 SH 197, Cuba, NM		
Subject: Arrow points to UV lamp status lights that were out.

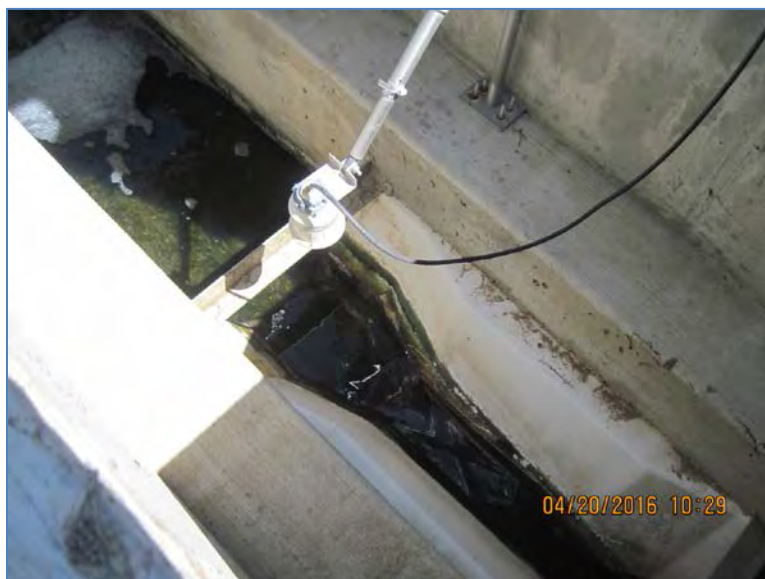
NMED/SWQB Official Photograph Log Photo # 6		
Photographer: Erin S. Trujillo	Date: 04/20/2016	Time: 1129 hours(corrected)
City/County: Village of Cuba / Sandoval County		State: New Mexico
Location: Village of Cuba WWTP, MM 2 SH 197, Cuba, NM		
Subject: White foam and algal growth was observed at the effluent flume.

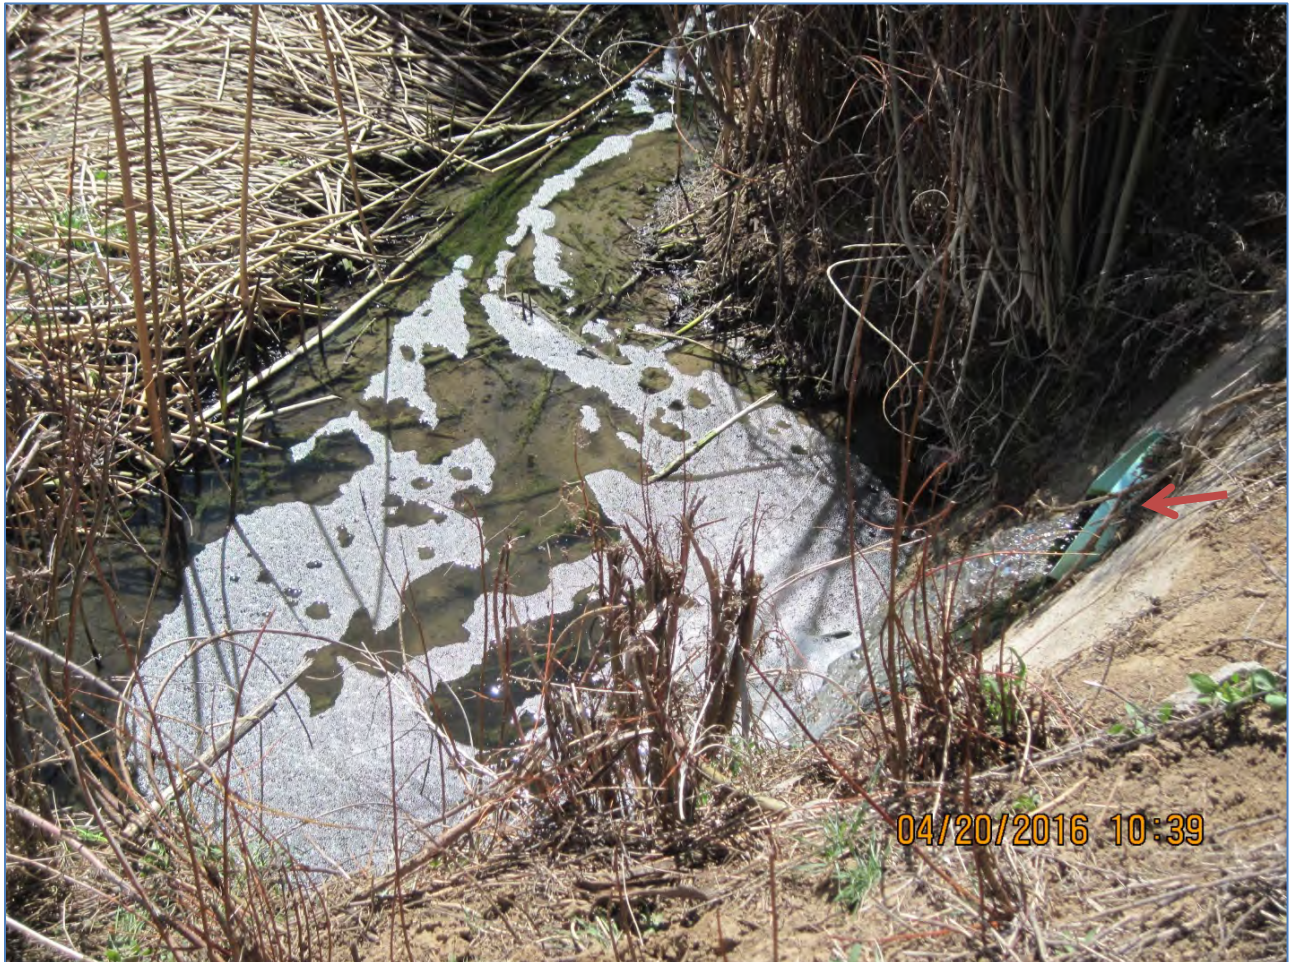
NMED/SWQB Official Photograph Log Photo # 7		
Photographer: Erin S. Trujillo	Date: 04/20/2016	Time: 1139 hours (corrected)
City/County: Village of Cuba / Sandoval County		State: New Mexico
Location: Village of Cuba WWTP, MM 2 SH 197, Cuba, NM		
Subject: White foam was observed in channel below effluent pipe outlet. Arrow points to outlet.

- Observed discharge was not authorized. Permittee continues to discharge on and after April 1, 2016 and on the day of this CEI.
- Outfall location is incorrect on Permits. The Signature Authorization page of the Permit describes the location as Latitude 35° 59' 35" North, Longitude 106° 59' 13" West, which is also the location indicated on Page 5 of 21 of the Permittee's 2015 NPDES application, which is near the entrance of the facility. The following is the approximate location of the effluent pipe outlet above the Rio Puerco:
